**Docket No. 217 – Development and Management Plan Inspection**

**Date:** April 28, 2004

**Location:** Norwalk Substation Expansion

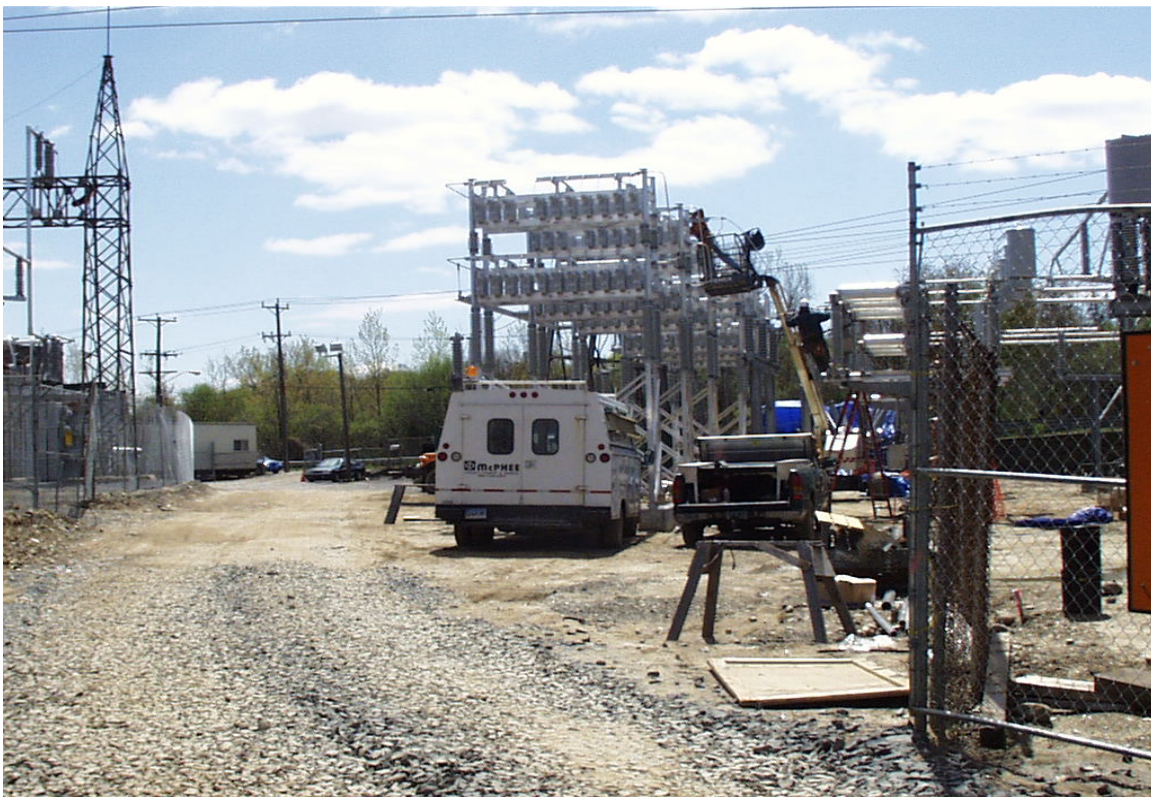
SOME SEDIMENT IS BEING TRAPPED IN THE GRAVEL PAD BUT THERE IS NO TRACKING ON THE ROADWAY. 4/28/04

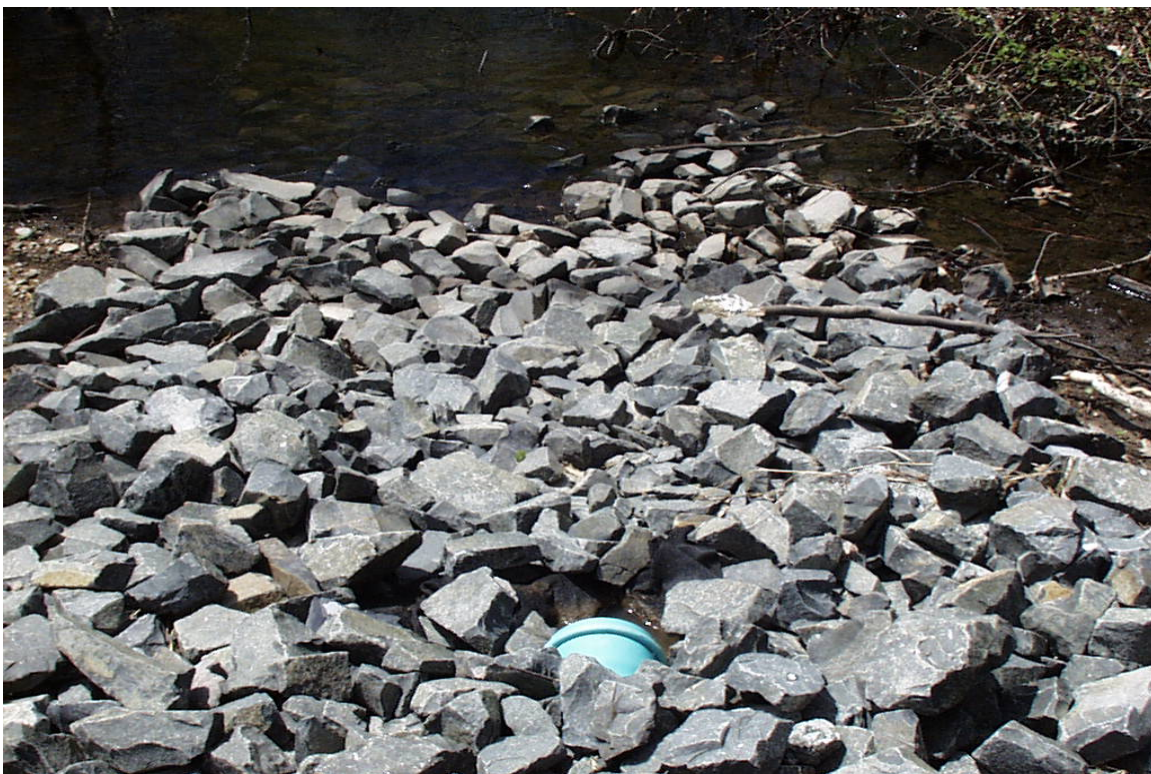
SMALL AMOUNTS OF FLOW WERE LEAVING THE OUTLET FROM THE SEDIMENT BASIN. SOME SEDIMENT HAD COLLECTED IN THE FABRIC BUT THERE WAS NO PLUME IN THE RIVER 4/28/04

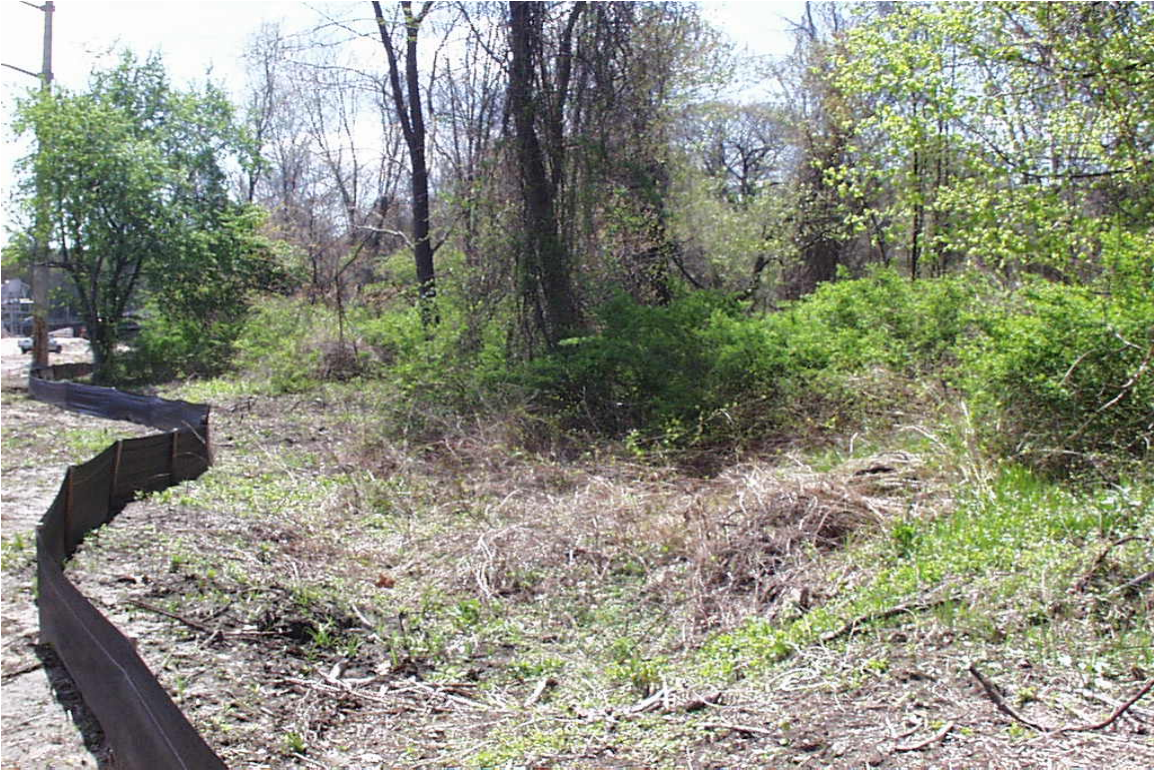
Vegetative clearing limits (including trees to save or danger trees noted)	<ul style="list-style-type: none"> <li>- The mulched and seeded areas were beginning to vegetate prior to being washed out in the floodwaters. The northern portion along wall #5 continues to vegetate 4/28/04</li> <li>- New growth of vegetation was noted near the riverbank at the time of inspection (including daffodils) however it may be necessary to revegetate here with a conservation seed mix if cover is not sufficient. 4/2-4/28/04</li> <li>- Roots and stumps are left in place here.</li> </ul>	<ul style="list-style-type: none"> <li>- New options such as shrub or tree plantings at this location may be necessary to create an established root system that can hold here. 4/28/04</li> <li>- Although some additional natural plant growth is occurring, we should know in a few weeks whether seeding for ground cover should be done in remaining bare areas. 4/28/04</li> </ul>

VEGETATION IS RETURNING TO THE RIVERBANK TO SOME DEGREE. SHRUBS AND TREES ARE LEAFING OUT. BARE SPOTS MAY REQUIRE SOME SEEDING IN SEVERAL WEEKS 4/28/04

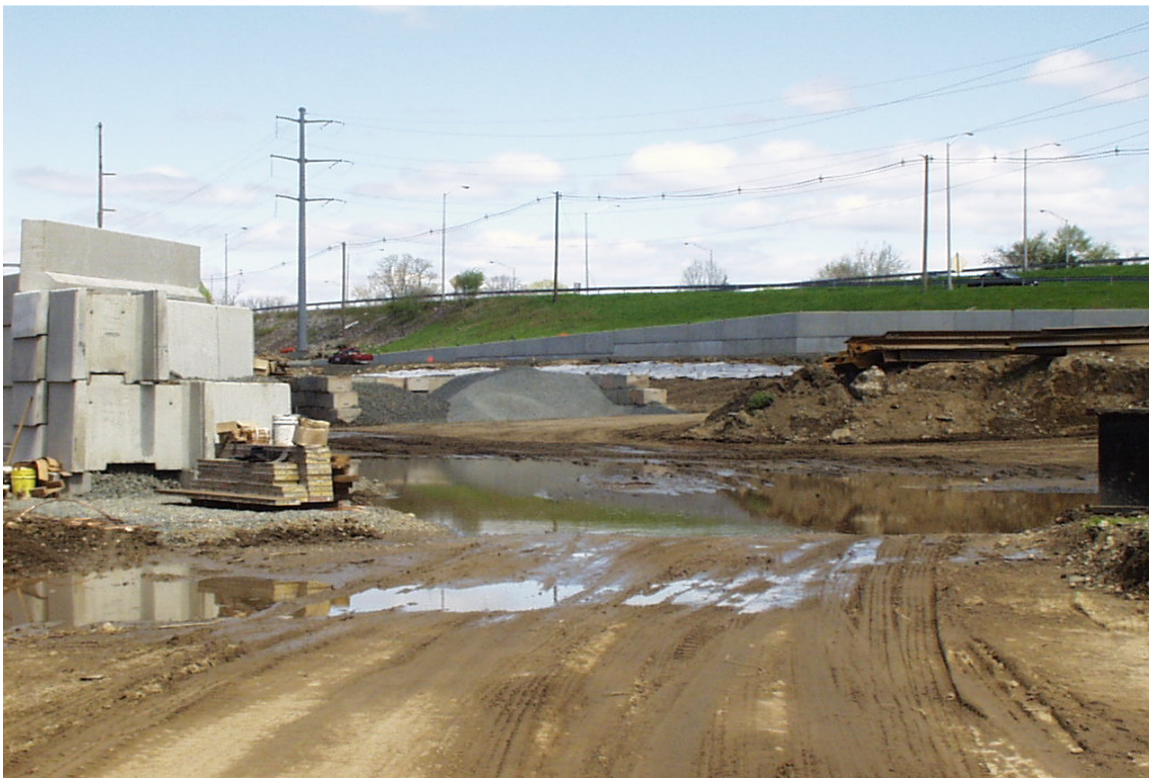
OVERVIEW OF SITE FOLLOWING ANOTHER STORM EVENT. CONDITIONS INCLUDED SOME STANDING WATER BUT NO ADDITIONAL EROSION. 4/28/04

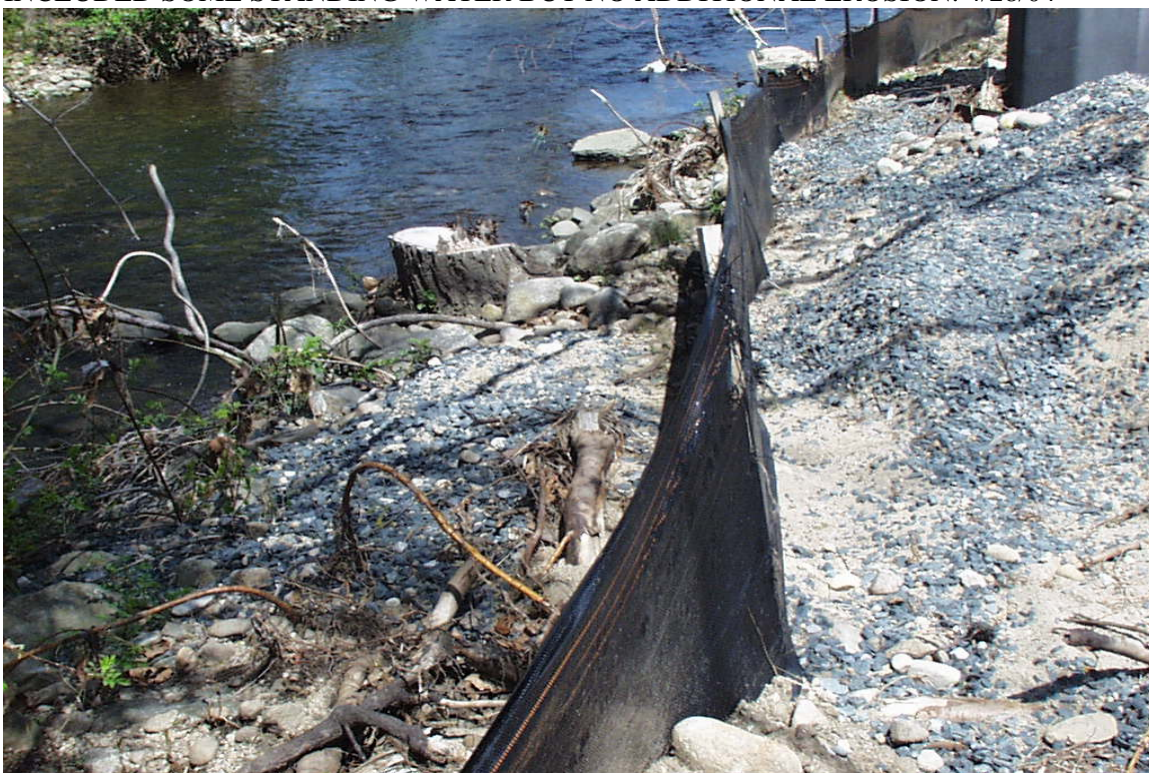
<p>- A small pile of bluish stone gravel that had migrated to the river bank from the base of the tower during the flood is on the river side of the silt fence. 4/28/04</p>	<p>- When possible, the stone should be hand shoveled back to the work side of the fence. 4/28/04</p>
	<p>- Rocky scour remains below the retaining wall #5 on the southerly portion until it can be restored. 4/21-4/28/04</p> <p>- Topsoil and emerging grass remain on the banks on the northerly portion of the bank below the retaining wall, however some minor slumping in the soil was noted. 4/28/04</p>	<p>- Discussions are ongoing for stabilization measures. The decision is leaning towards tubeling shrub planting and plantable geogrids for structure. 4/28/04</p>
Inland Wetland and Watercourse encroachment and mitigation	<p>- The silt fence has not been damaged by the most recent storm. 4/28/04</p> <p>- The riprap outlet from the sediment is showing small amount of flow to the river but</p>	<p>- Continue to monitor silt fence and repair as necessary, especially in portions closest to the river. 4/28/04</p>

AREA WHERE GRAVEL HAD BEEN WASHED OVER THE SILT FENCE DURING THE STORM. WHEN FEASIBLE, THE STONE SHOULD BE SHOVELED BACK ON THE WORK SIDE OF THE FENCE. 4/28/04

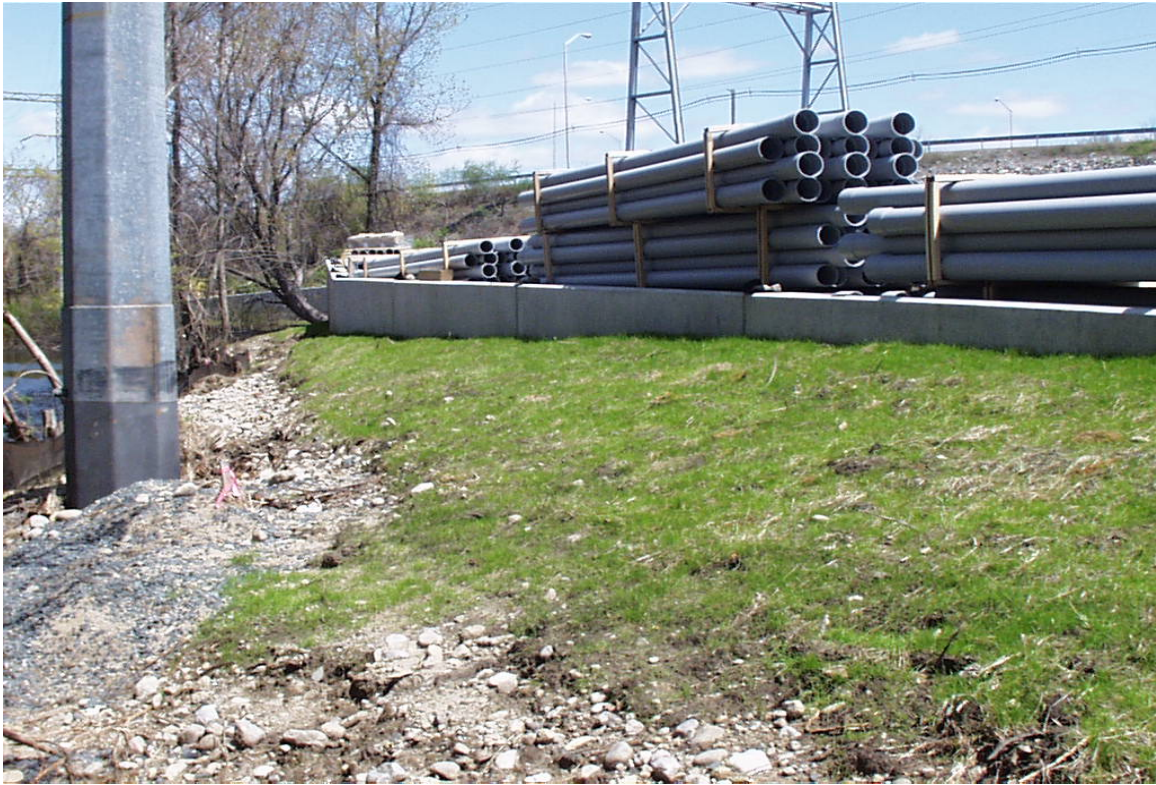
Areas of Inspection	Observation	Recommended Action
	<p>all sediment is being captured. 4/28/04</p> <ul style="list-style-type: none"> <li>- The area below retaining wall #5 on the southern portion remains rocky and scoured following the flood washout while final stabilization decisions are being made.</li> <li>-The topsoil remains and vegetation is beginning to grow on the northern end, however there is some slight slumping the soil 4/28/04</li> </ul>	<ul style="list-style-type: none"> <li>- Additional methods for stabilization are being decided. Measures will likely involve soil holding grids with quick growing shrub tubelings planted. Arrangements may be made soon to obtain willow (<i>Salix</i>) plantings. 4/21/04</li> </ul>
State species of concern, threatened and endangered species	<ul style="list-style-type: none"> <li>- No species of concern are located in this area of construction.</li> </ul>	<ul style="list-style-type: none"> <li>- N/A</li> </ul>

VIEW OF THE SCOURED AREA. THE AREA WILL BE RESTORED AND STABILIZED AS GRASS IS GROWING IN ON REMAINING TOPSOIL. 4/28/04

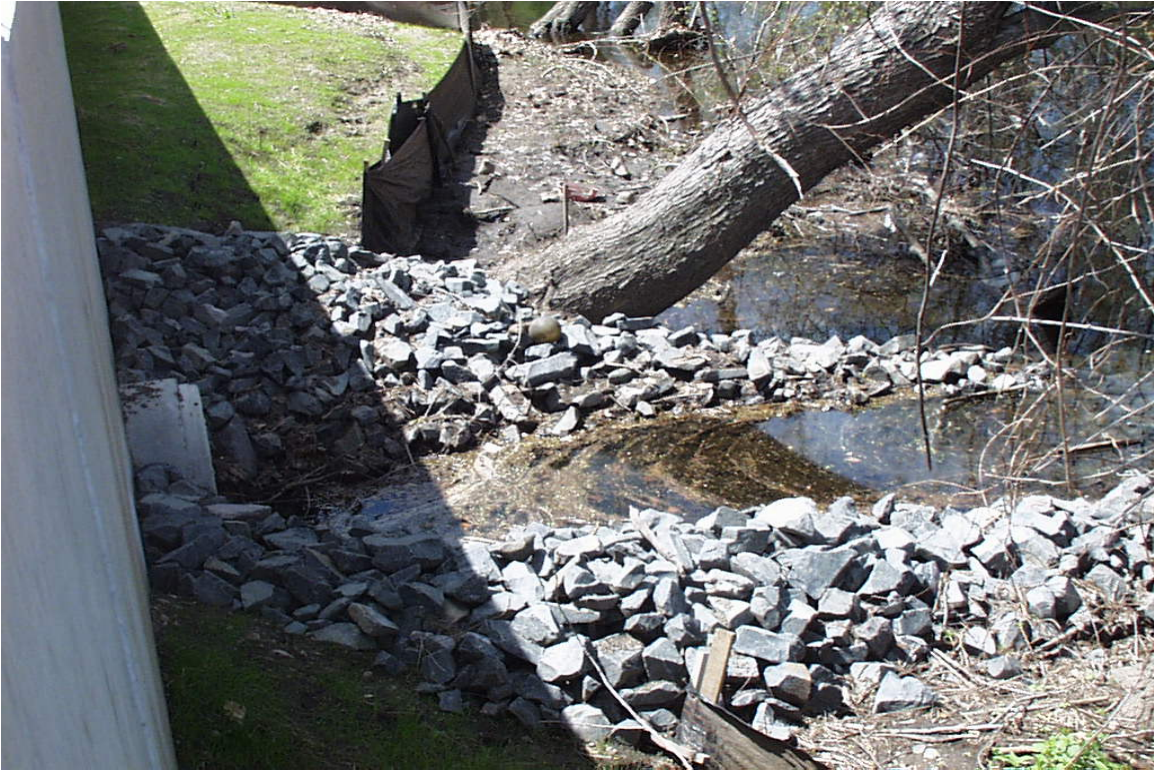
CULVERT AT RIVERBANK FITTED WITH RIPRAP OUTLET. 4/21/04

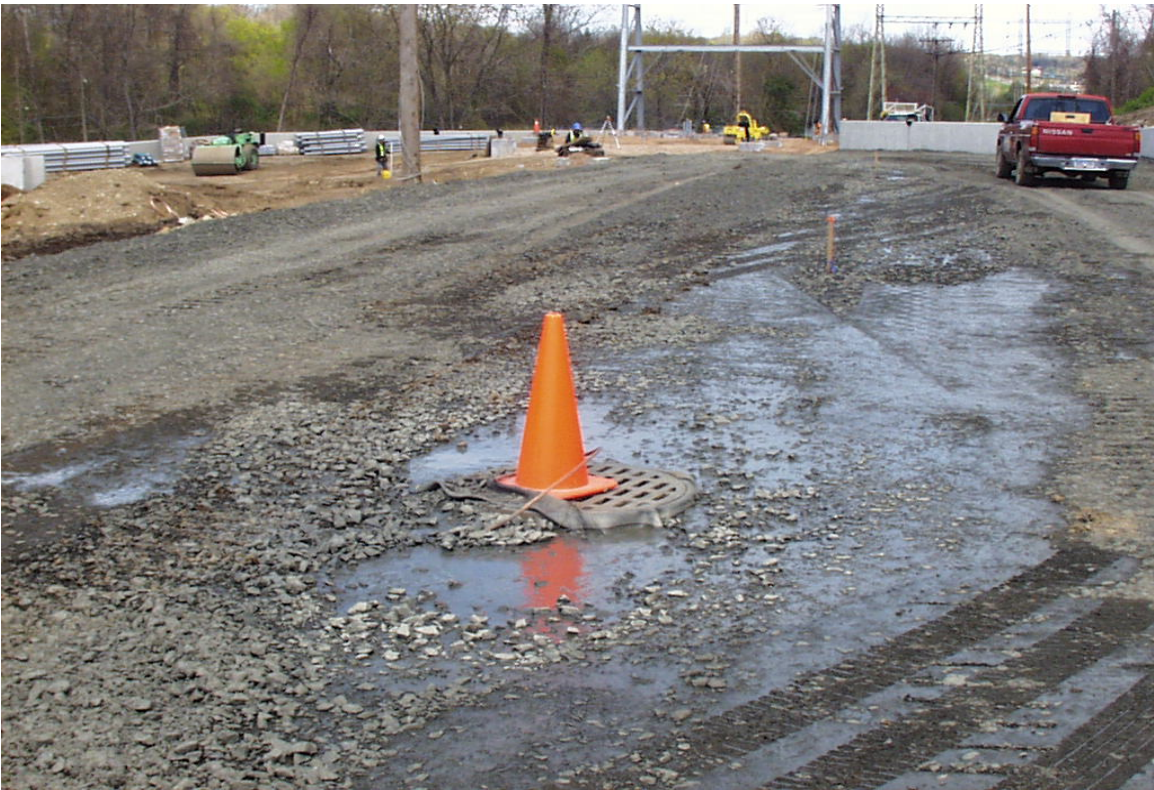
FILTER FABRIC APPROPRIATELY PLACED UNDER CATCH BASIN INLET GRATE WITHIN PARKING AREA. GRAVEL AND BASE MATERIAL HAS BEEN PLACED HERE. 4/28/04
